The Hand Drill

A T A L E O F R E J U V E N A T I O N

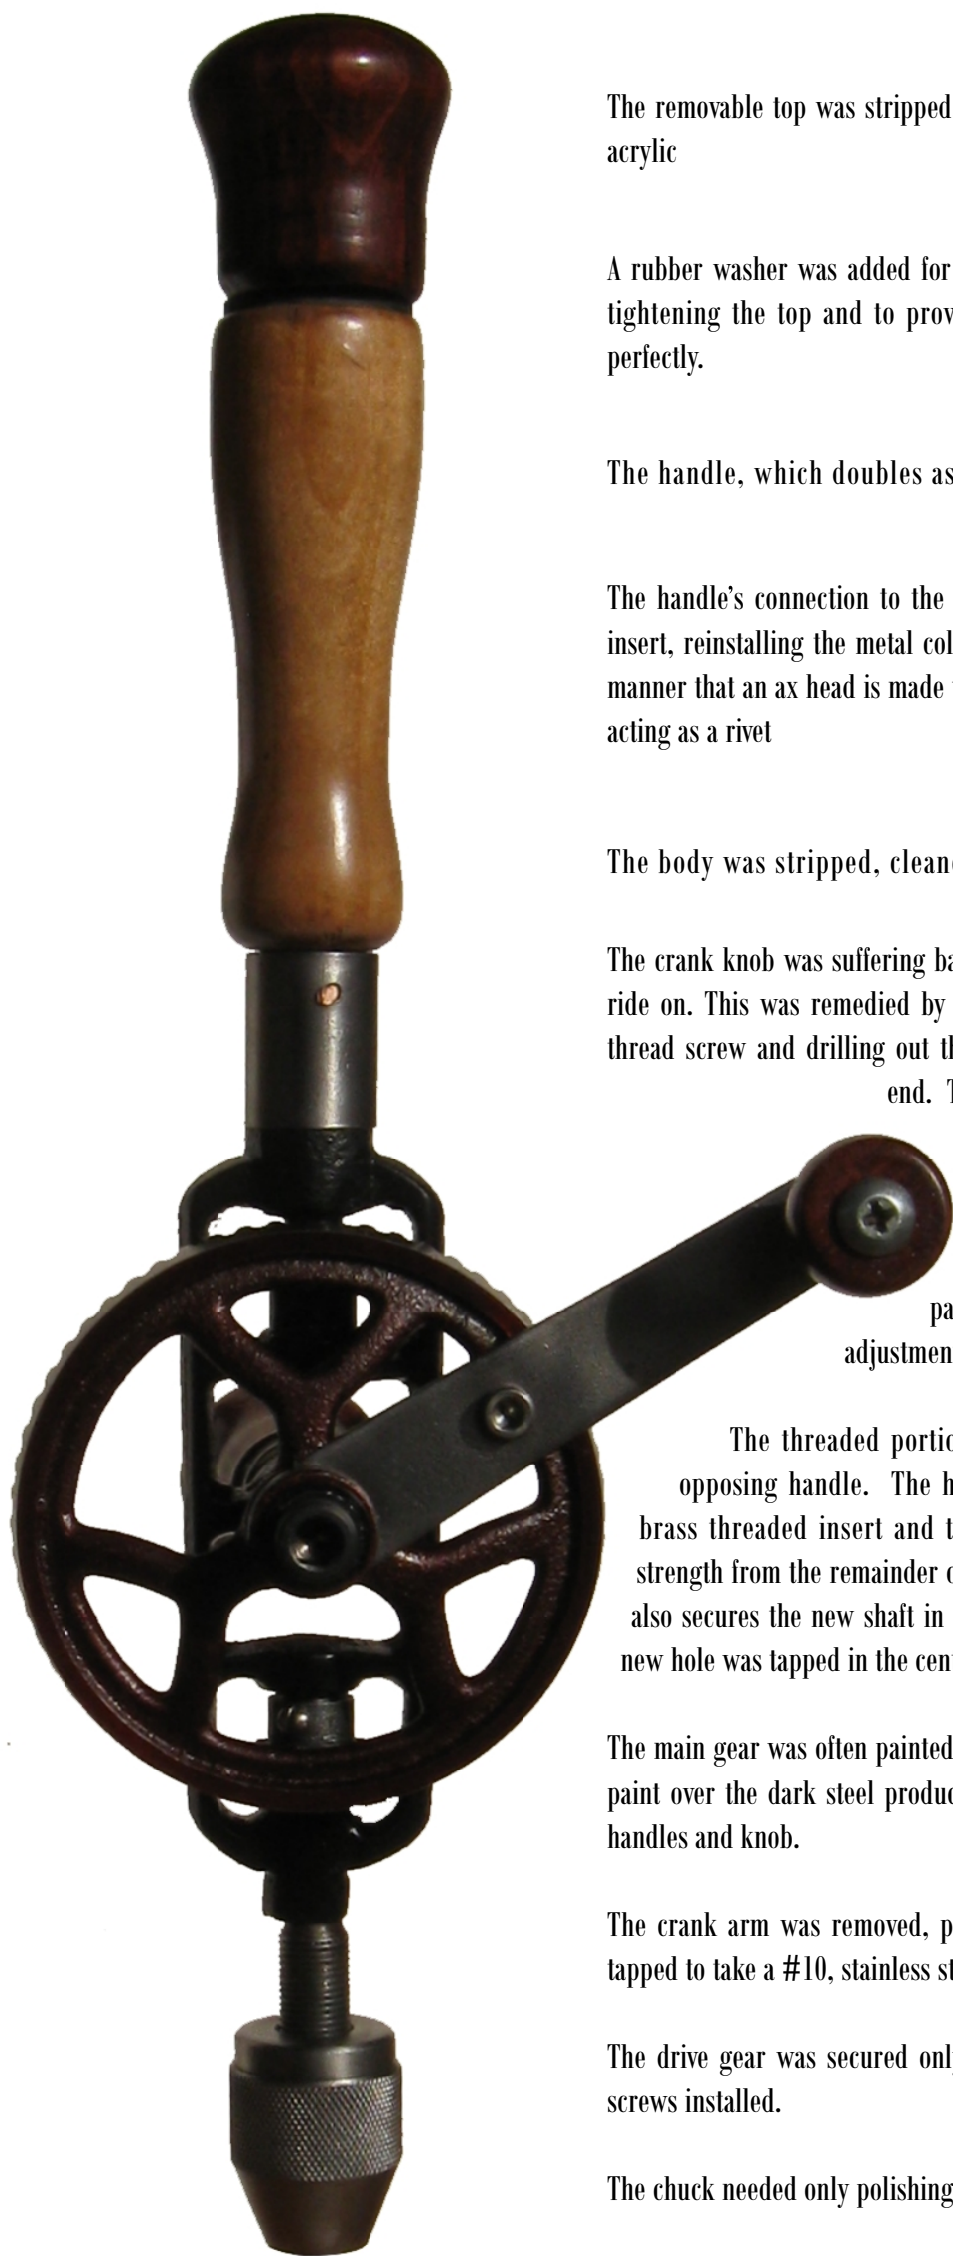
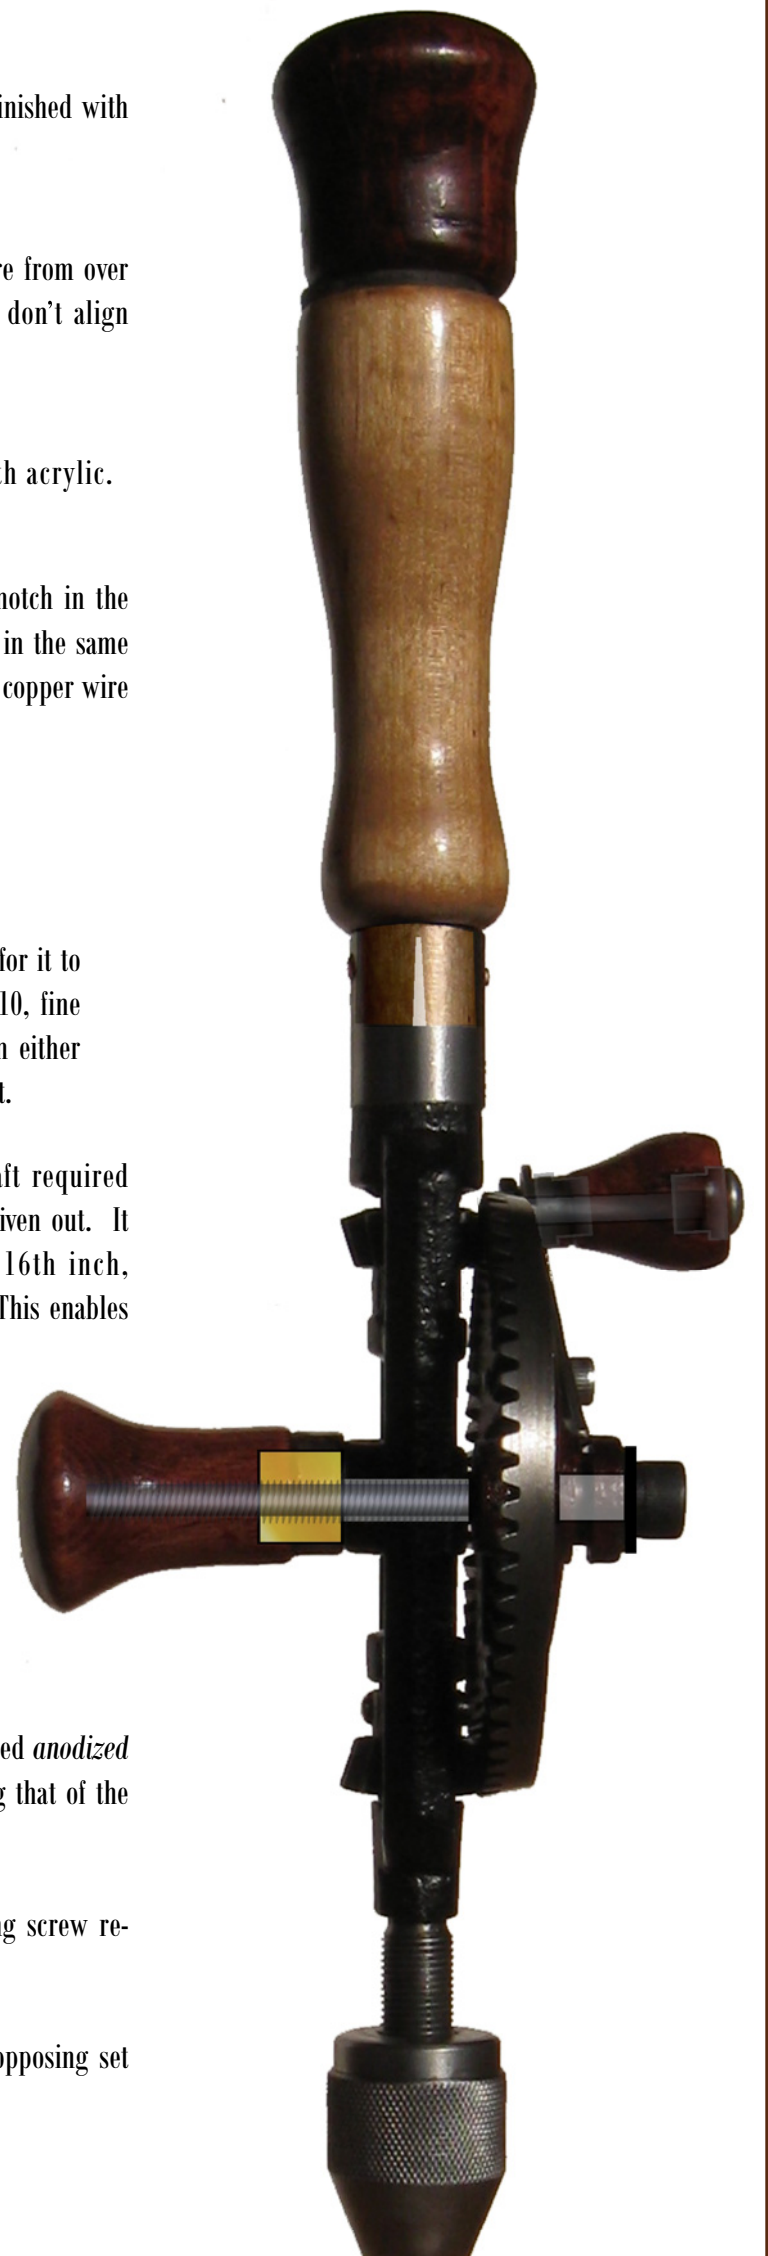
This drill, given to me by my father, belonged to my grandfather. It has no brand markings on it. It is likely an inexpensive version of the renowned Miller's Falls or Goodell-Pratt hand drills. Still, its sturdy construction and essential good character made it a suitable choice to refurbish. The goal was to restore, and even improve on, the original design and end up with a hand drill that looked like an antique, but would be a good and valuable, everyday working tool. The result, a hand drill that has a sturdy feel, smooth action and perhaps another century of useful service.

The removable top was stripped, repaired and re-stained in *cabernet*, then finished with acrylic

A rubber washer was added for two reasons. To absorb some of the pressure from over tightening the top and to provide a visual break between the parts that don't align perfectly.

The handle, which doubles as bit storage, was stripped and sealed with acrylic.

The handle's connection to the cast iron body was improved by cutting a notch in the insert, reinstalling the metal collar and then driving a wedge into the notch in the same manner that an ax head is made tight. The assembly was then secured with a copper wire acting as a rivet

The body was stripped, cleaned, primed and painted gloss black.

The crank knob was suffering badly from wear caused by the lack of a shaft for it to ride on. This was remedied by tapping the hole in the crank arm for a #10, fine thread screw and drilling out the knob to accommodate a nylon bushing on either end. The position is retained by a stainless steel nut.

Replacing the un-threaded center shaft required progressive drilling until it could be driven out. It was re-bored and replaced by a 5/16th inch, partially threaded, 3-inch socket head screw. This enables adjustment of the main gear; a big improvement.

The threaded portion then provides a sturdy mount for the opposing handle. The handle was drilled out to accommodate a brass threaded insert and the handle further drilled to gain added strength from the remainder of the machine screw. The tightened handle also secures the new shaft in place, but to make sure it does not drift, a new hole was tapped in the center bearing and a set screw installed.

The main gear was often painted bright red as was this one originally, but a red *anodized* paint over the dark steel produced a rich burgundy color closely resembling that of the handles and knob.

The crank arm was removed, polished and sealed with acrylic. Its retaining screw re-tapped to take a #10, stainless steel socket head screw.

The drive gear was secured only by a pin. These holes were tapped and opposing set screws installed.

The chuck needed only polishing and lubrication.
